WEFTA/WATERLINES-SPONSORED TRIP CHIAPAS, MÉXICO

Project: Benito Juarez Miramar – Chiapas, Mexico

Inspection Report: Kees Grootenboer

Project: Laguna Chum Cerro – Chiapas, Mexico

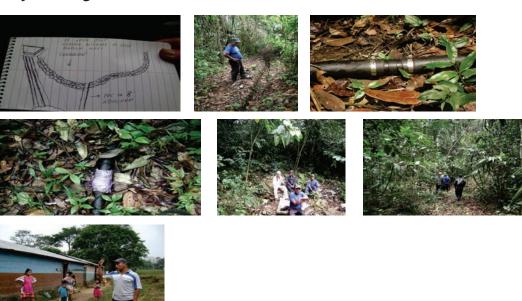
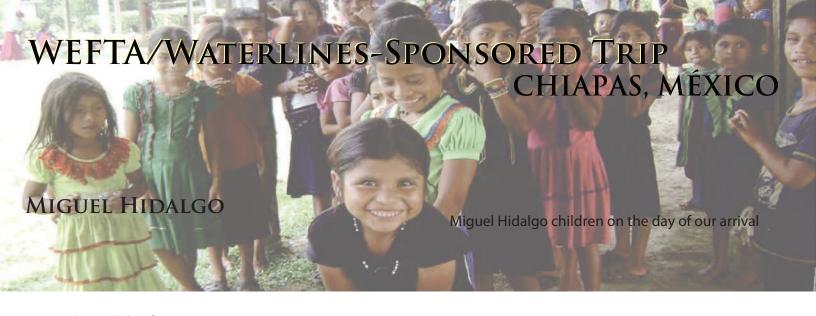
Project Images:

While conducting an inspection of the *manantial* catchment tank, it was decided that additional work was needed to fully contain all available water from the spring. The additional work will consist of installing a protected containment tank with a protruding eight-inch PVC waterline. Water from the containment tank will be directly piped to an existing spring catchment tank that delivers water directly to the community.

Between the spring catchment tank and the community water storage tank there is a section of approximately 750 meters where the waterline crosses a section of land that is slightly elevated. In order to maintain good gravity between the spring catchment tank and the community water storage tank, the community will dig the trench an additional 50 centimeters to maintain good gravity.

In addition, there are five sections in the distribution line between the spring catchment tank and the community water storage tank that are leaking and need repairs. Two of the leaks are at the location where two pipes were joined together and the remaining three are due to fallen trees.

Due to community growth, there are additional households which have been built at a similar elevation as the community water storage tank. As a result, these homes are getting very little pressure. Three ideas where discussed to address this issue; make the existing community water storage tank taller, install a small booster pump that can be run with solar power, and a waterline tied directly from the waterline from the spring before it enters the tank to the new homes.

After some discussion, it was agreed that the most cost-effective alternative is to run a direct distribution line from the waterline from the spring before it enters into the tank to the new homes.
