MONTES AZULES BIOSPHERE RESERVE

TRIP REPORT

Related to Site Visit made by Emily Sotelo, P.E. and Ramón Lucero, Jr.
to the State of Chiapas, Mexico
February 24 – March 7, 2018

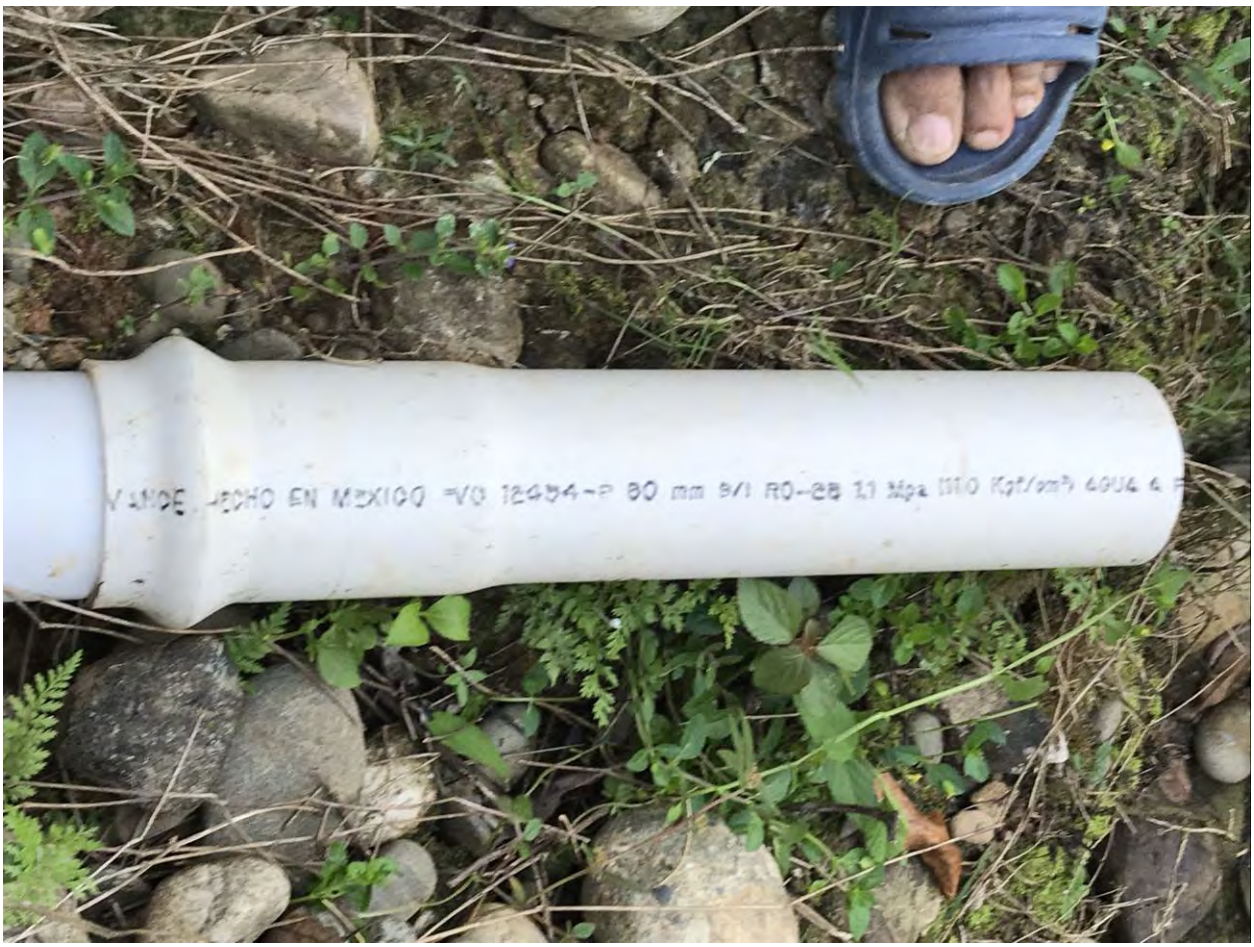
Along with the wells, the government installed approximately 40-percent of the distribution system between the production well and the community. However, the majority of waterline is cracked, or all together broken making it useless for future use.

Check pressure rating for this pipe
