WEFTA Site Visits to the Urubamba Valley of Peru and the Bolivian Altiplano January/February 2014

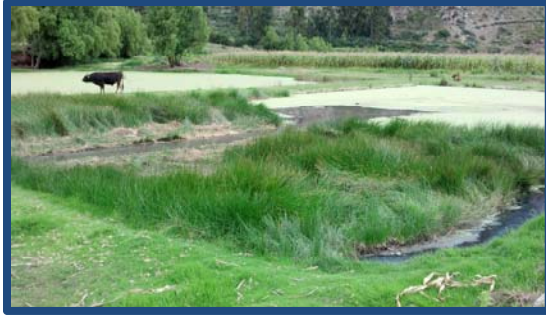
The town of Huayllabamba has a facultative wastewater lagoon system that failed several years ago and that they wish to rehabilitate and bring back online. The revamped lagoon system will be designed to accommodate not only the wastewater produced by the town of Huayllabamba (population of 1,741), but also that of the neighboring community of Urquillos (population of 899), as well as the large Hotel Aranwa (guest capacity of approximately 230).

L – Failed lagoons at Huayllabamba

The WEFTA team discussed various project specific concerns and design parameters considered, and shared insights with the local public works staff and hired consultant both at the municipal headquarters and at the site of the lagoons. The dynamic of the meeting was really more of a brainstorming session over how to deal with construction of the lagoons and the challenge of dealing with a site directly adjacent to the Urubamba River. The general feeling of the WEFTA engineers was that the town was on the right path in terms of treatment technology and agreed that the greatest challenges had to do more with flood protection of the lagoons due to their proximity to the river and the potential effects of fluctuating groundwater levels on the lagoon system.
